## Site location

The site I chose to observe is the Antelope Creek near my home. This creek runs in-between Interstate 94 and North Dakota highway 21 and feeds into the Heart River. It is located about 10 to 15 miles north of Carson, ND. This creek is currently under a watershed recovering program to help reduce the effects of erosion. These pictures are taken near my ranch. The blue dot in picture two is where these pictures were taken and shows the tail end of the creek.

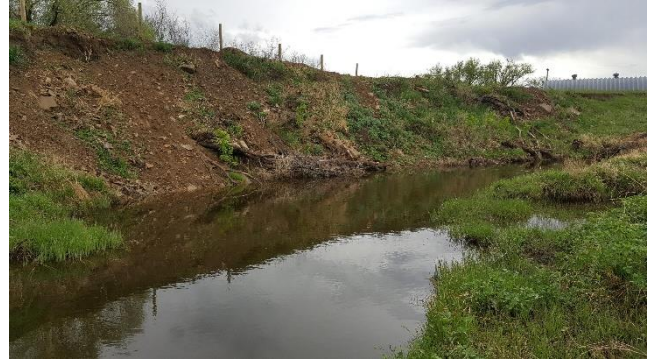
Picture #1

The consequences of further weathering and erosion will result in large steep cut banks that will be dangerous to live by. Currently a road runs on the top of picture #1 that will be washed away if these processes continue. The fertile agricultural land that surrounds the creek will be lost. Reservoirs and lakes can fill up with sediment from upstream, and contamination from pesticides can erode the soil. The erosion process will move towards the end of the creek where it will cause the most damage. Pasture land will also be lost.

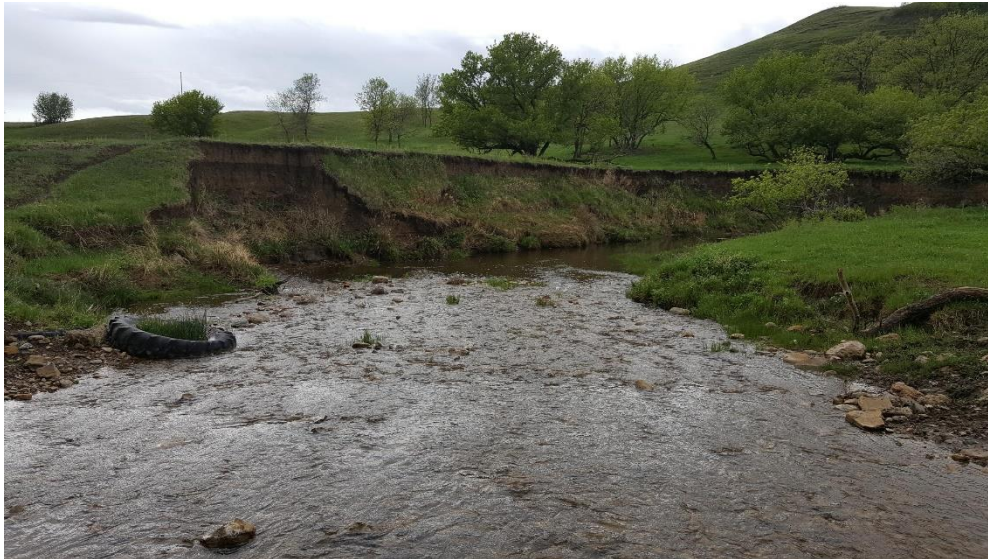
Picture #3

The type of weathering that is taking place on the Antelope Creek is mass wasting. This is the process of relocating rock material downslope due to gravity. In picture #3 you can observe large pieces of land sliding down the steep slope of the banks. The causes of mass wasting include how saturated the surrounding soil is, how steep the slope, and available vegetation. Mechanical weathering is also taking place as pieces of sod and clumps of dirt are being broken down into smaller pieces.

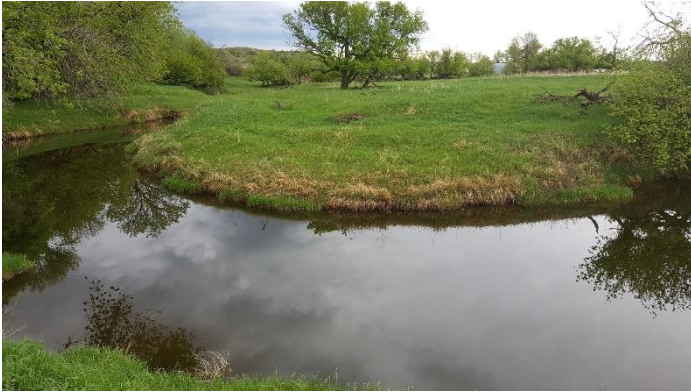
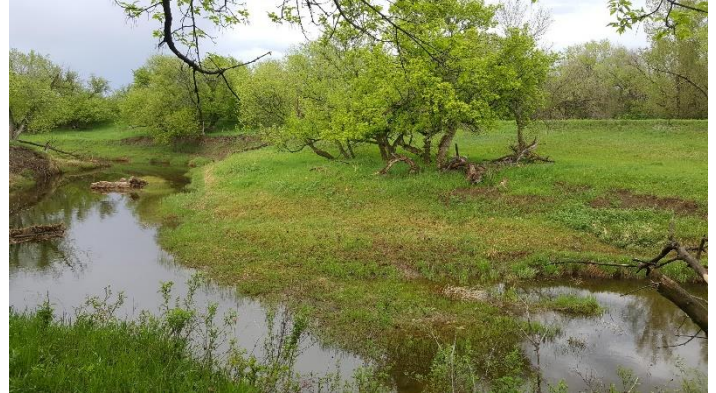
The natural state of this creek once had smooth gradual banks with grass growing up to the creek. These pictures show areas of the creek that have not experienced much erosion or weathering.
